## **Appendix B**

### **Monitoring of Wall Drying Characteristics in a Temperate Rain Forest Environment**

**By Marquam George**

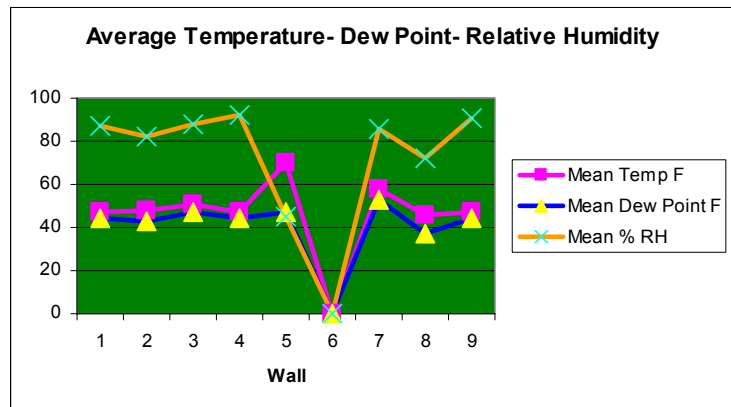
Average Wall Cavity Dew Point Temperature and Relative Humidity  
05/01/2003 – 06/01/2004

\*Wall #6 data removed due to logger failure from excessive condensation. Data logger failed 01/16/2004.

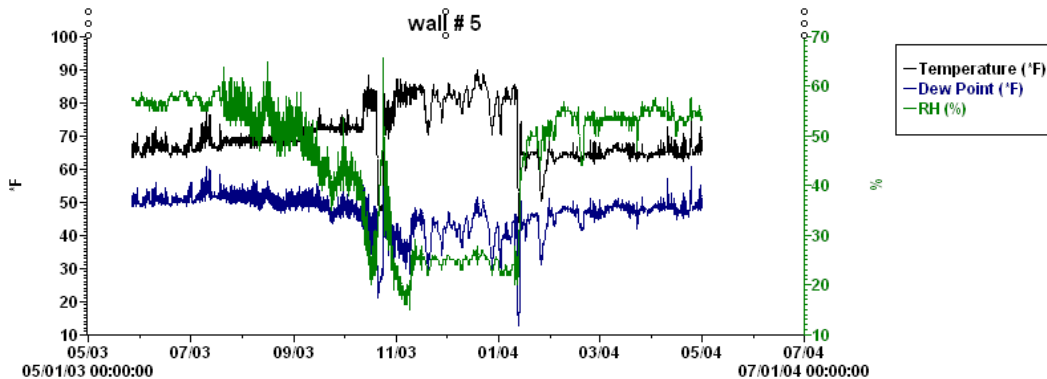
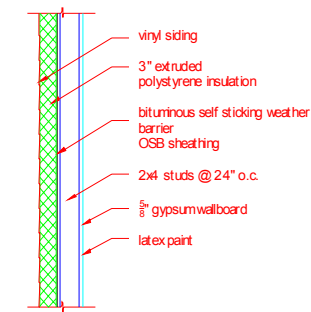
**WALL SECTION 5**  
 SC. 1" = 1'-0"

**Wall #5**

All insulation on the exterior on the structure.

Structural components stayed the same temperature and humidity as the ambient interior living conditions.

Average moisture content of framing and sheathing components : < 8%
