## **Appendix B**

### **Monitoring of Wall Drying Characteristics in a Temperate Rain Forest Environment**

**By Marquam George**

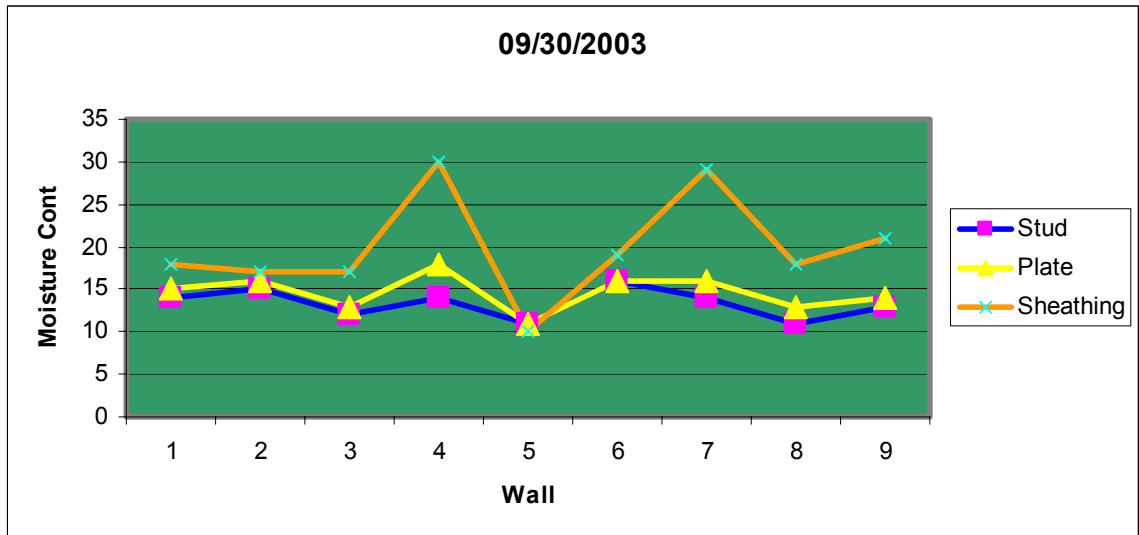
Moisture Content Measurements of 09/30/2003

Wall	Stud	Plate	Sheathing
1	14	15	18
2	15	16	17
3	12	13	17
4	14	18	30
5	11	11	10
6	16	16	19
7	14	16	29
8	11	13	18
9	13	14	21

The drying trend of the framing members and the increased moisture content of the sheathing amplified as the test continued into the winter season. The moisture content of the sheathing reached its highest measured moisture levels during the January moisture recording. Comparison of the absolute humidity levels between the interior of the test lab, the interior of the wall cavities, and the exterior environment indicated that a significant outward vapor drive was occurring during that time.
