COLD CLIMATE HOUSING RESEARCH CENTER

CCHRC Roof Hydrology During Spring 2007 Break-up

*Colleen Rust, Daniel Reichardt,
Jeff Derry and Michael Lilly
GW Scientific
October 27, 2007*

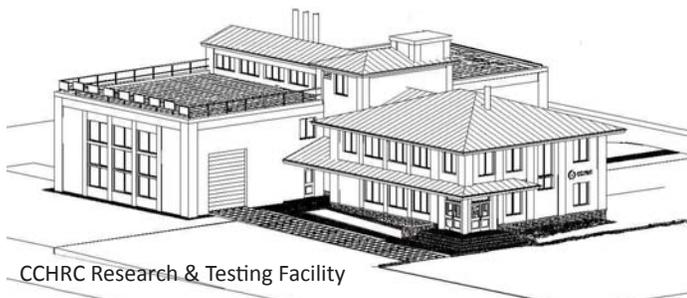
Figure 1. CCHRC Research and Test Facility (RTF). Green roofs are on west side, the main office roof is on the east side.

The Cold Climate Housing Research Center building has two green roofs in addition to its standard roof. During the 2007 spring break-up, we monitored various snowmelt and runoff processes of the CCHRC building and surrounding grounds to gain general knowledge of water dynamics and look at volumes of available water from both green roofs, and the roof of the administration building (Figure 1, 2).

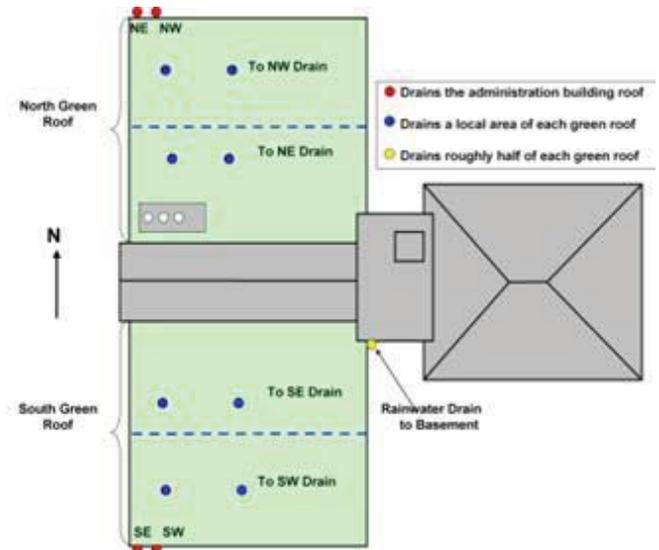
Figure 2. There are two green roof test systems, one on the North Bay, and one on the South Bay. Each of the green roofs has two drainage areas dividing the roof approximately in half. The Office Roof System has gutters that catch runoff from the south and east sides and drains to holding tanks in the basement.

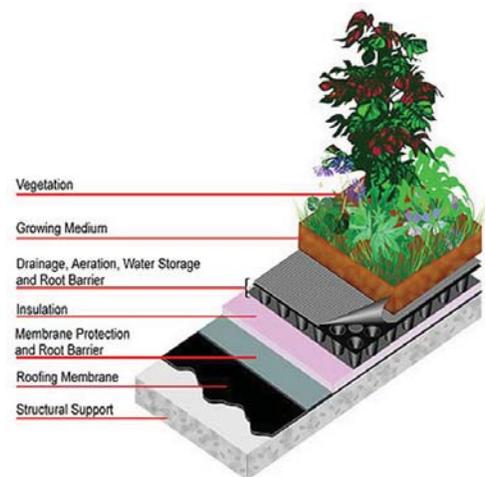
Figure 3. Typical profile through a green roof system.

Snow-pack measurements were made on each green roof (Figure 3) and the snow-water equivalent (SWE) for the end of winter was estimated. This was done by establishing snow-depth transects on each roof and measuring three snow densities at each transect.

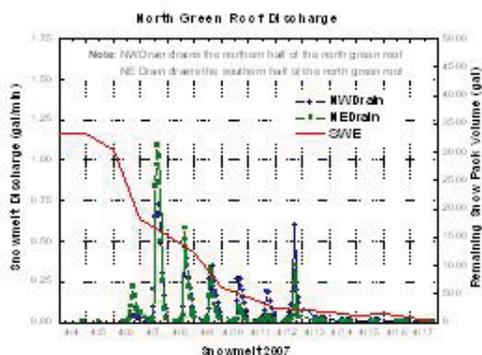
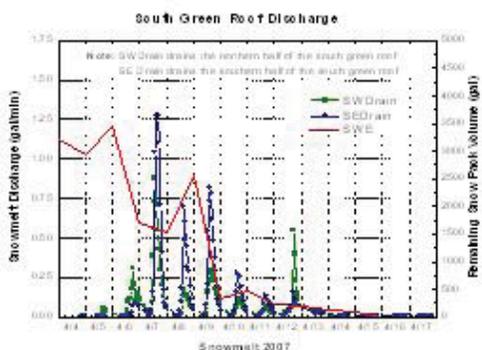
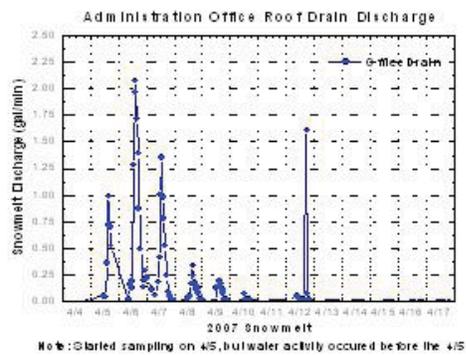
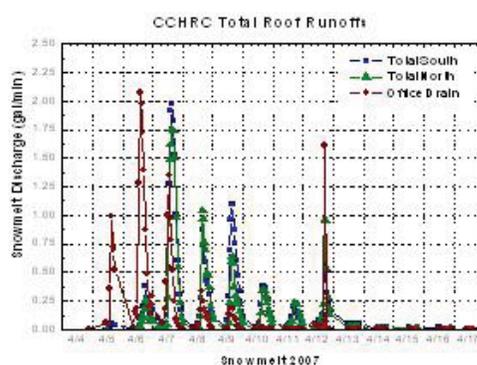
Figure 4. Snowmelt observations from the three roof areas are shown in the graphs to the left and right. The graphs on the right show the reduction in SWE on each roof and the runoff from the roof drains. The diurnal runoff trends can be seen in the individual measurements.

- Peak runoffs were ~ 1-2 gal/min.
- One-day time lag between the administration building roof and the green roofs.
- A rain event on 4/12/07 shows up as a stronger peak on the office roof versus the two green roofs.
- Preferential melting occurred around the green roof drains.

Discharge from the roof drains were also measured during snowmelt to calculate the amount of water draining from each roof (Figure 4) Runoff from each drain was measured for the two green roofs and the volumes were added together. The drain from the office shingled roof drains the southern and eastern side of the office roof. Pictures were taken to record the distribution of snow during snowmelt (Figure 5, 6).

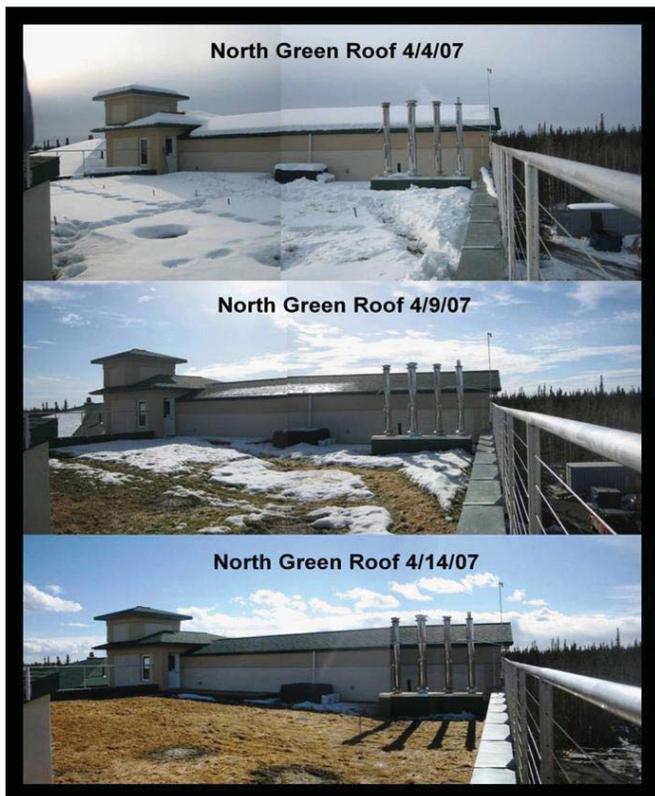
Figure 5. Snow distribution is shown for the North Bay Green Roof. Over the 10 day period shown, most of the snow has melted. The south side of this roof is shaded by the mezzanine roof. The northern side of the north roof melted out earlier due to the sun exposure. Paths also melted out before the shaded southern side of the roof.

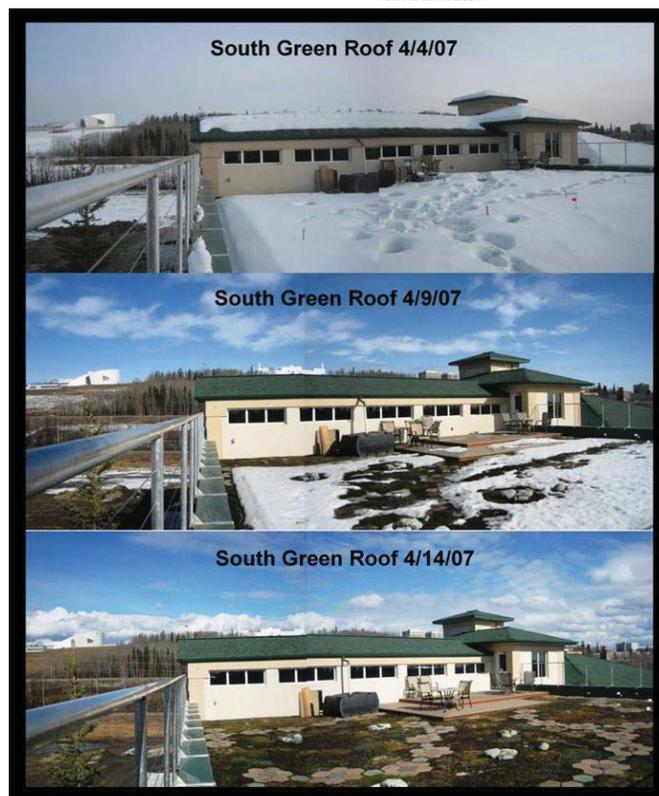
Figure 6. Snow distribution is shown for the South Bay Green Roof. This roof receives less shading. Melting around the roof edges can be seen in the middle photograph. Paths and disturbed areas in the snow also melted earlier. The mezzanine roof drain also contributed water during snowmelt.
